## Probleme SPI Vakuumschläuche

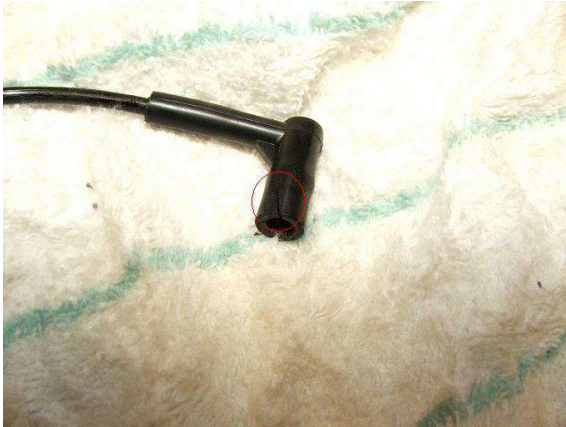
First things to look for when your SPI engine is not running quite right are air leaks. These leaks are usually the ends of the little black, red and yellow capillary lines, they tend to split as shown below and play havoc with the vacuum reading of the ECU. They should be a very tight fit and nothing less than excellent condition.

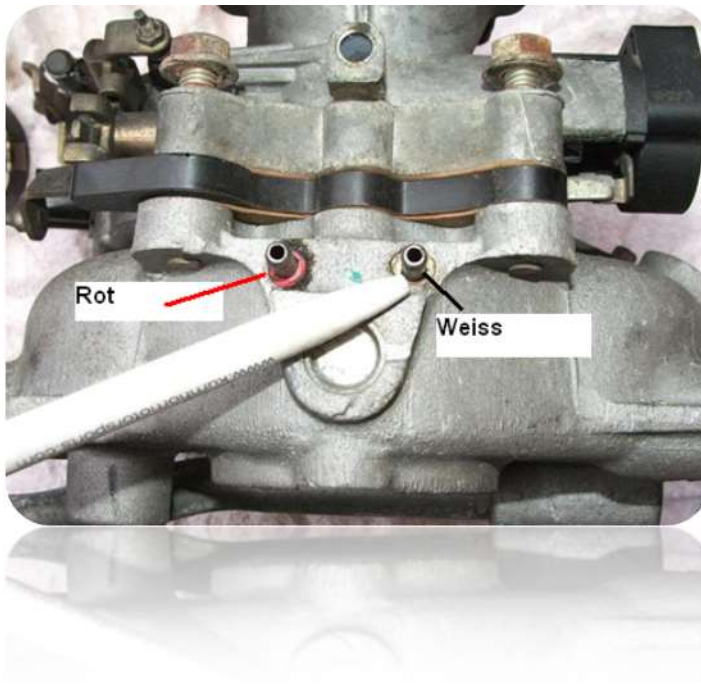
The main one that seems to cause a problem is the one on the end of the short capillary **identified with white**, from the back of the inlet manifold to the fuel trap. Located on this port on the back of the inlet manifold, again identified with white.

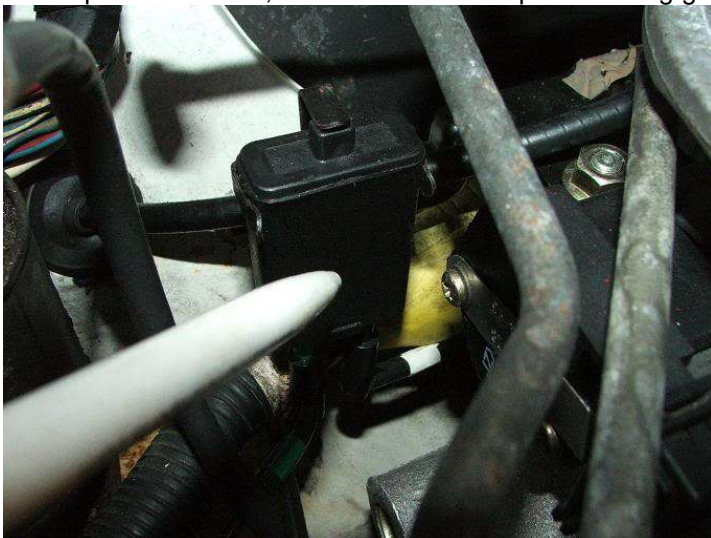
The fuel trap looks like this, has one short black port and long green

port.

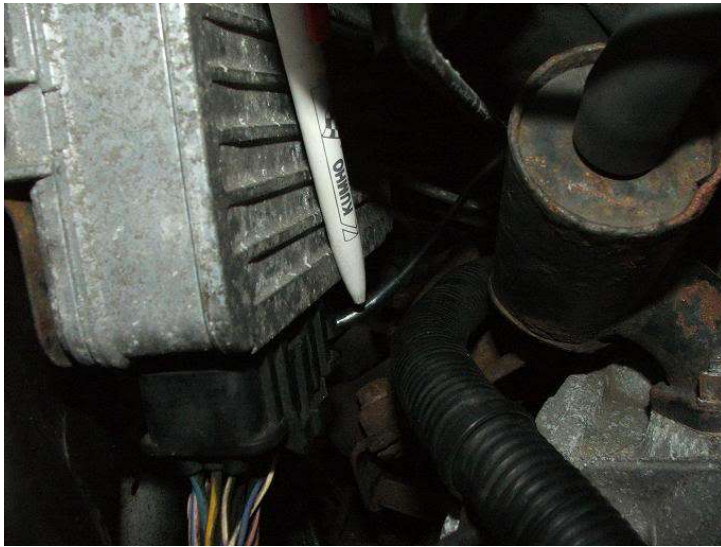
While on the subject of capillary tubes and fuel traps, there is a known problem of fuel causing blockage in these tubes, mainly the one identified with green, attached to the long green port of the fuel trap and the ECU at the other end. The symptoms of this are, hesitation when accelerating usually accompanied with a backfire in the inlet manifold and the car usually bucks violently. The only fix for this is to remove the tubes along with the fuel trap and blow through, remove the ECU and insert some cotton wool into the MAP ( Manifold Absolute Pressure) sensor port and place the whole thing on a warm radiator over night. This is what is suggested in in a Rover service bulletin. Also ensure the capillary ends are in nothing less than excellent condition as above. The MAP sensor port as shown.

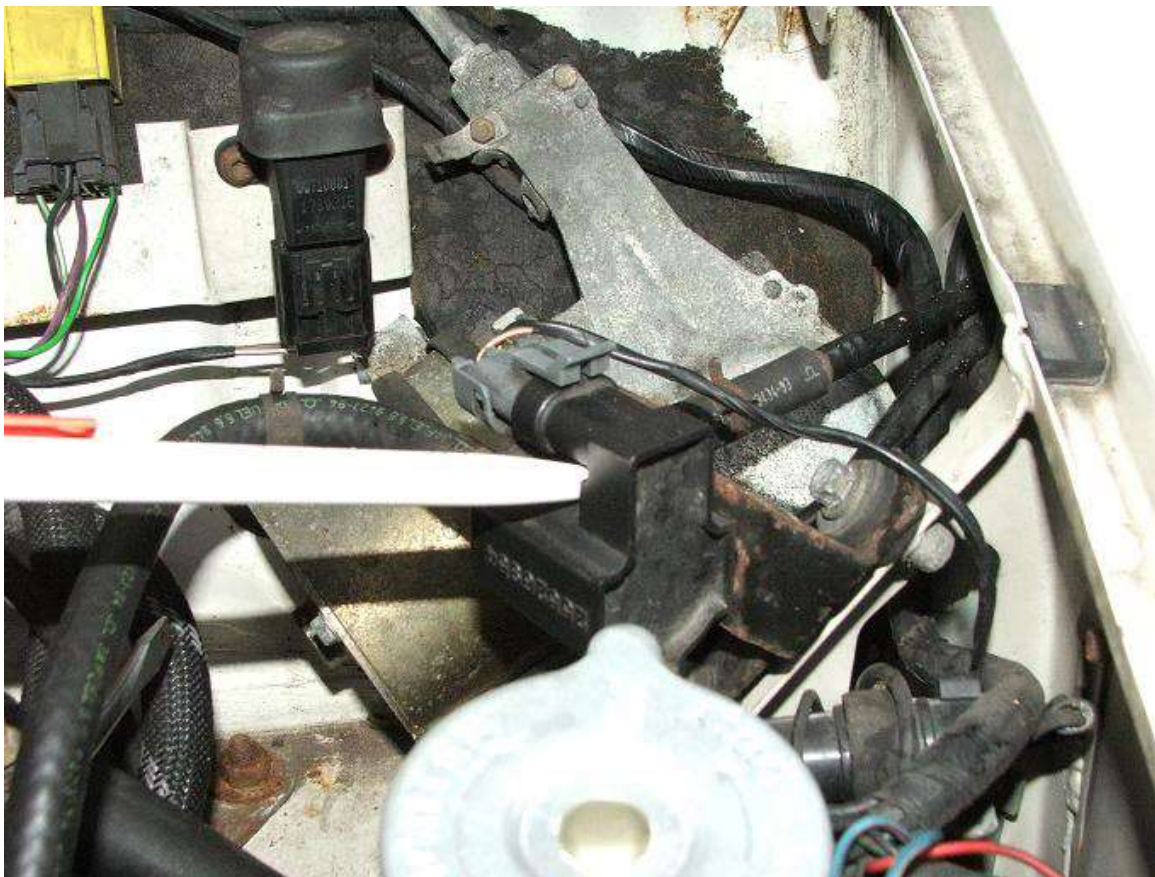
Other locations of air leaks are the breather system hoses and the evaporative emissions control system. Check all rubber hoses are in good condition, no cracks or splits. **The main breather hoses to check are the ones supplying the purge valve and the charcoal canister. They usually leak at the purge valve shown here.**
